TECH
REPORT

F1 crash tests

BARRIER BREAKTHROUGH

New high-speed barriers have been implemented at Formula One circuits in 2017, following tests by the Global Institute for Motor Sport Safety

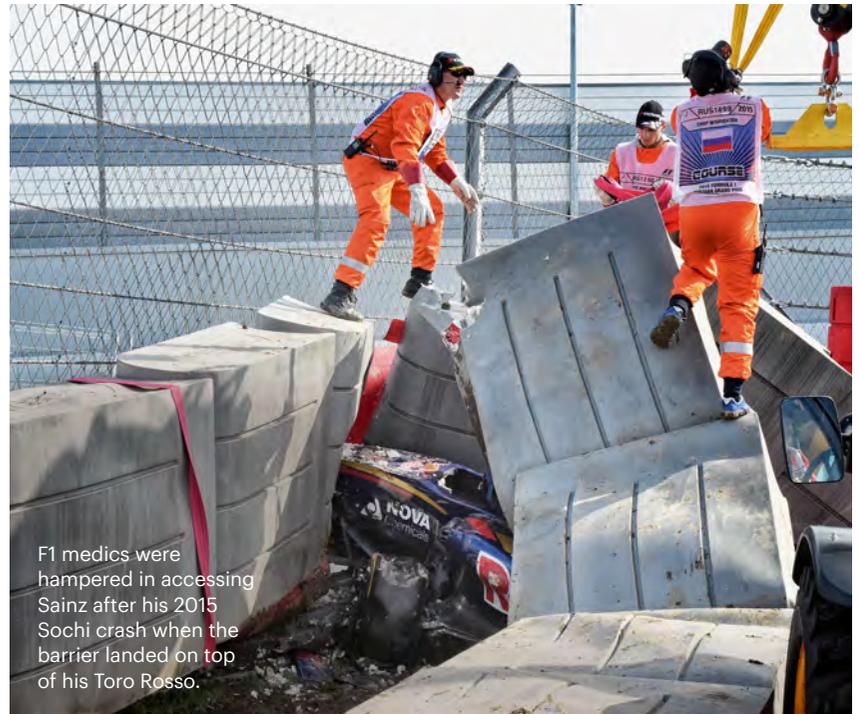
F1 medics were hampered in accessing Sainz after his 2015 Sochi crash when the barrier landed on top of his Toro Rosso.

For Carlos Sainz Jr, it was all over in a few seconds. The Spaniard lost control of his Toro Rosso at Turn 13 during the third practice session of the 2015 Russian Grand Prix, glanced off the nearside wall damaging his brakes and slammed nose-first at high speed into the barrier at the far end.

He hit that barrier head-on at 153km/h, one of the highest impact speeds measured in Formula One in the last few years, and came to a complete stop in about four metres. The Accident Data Recorder on his car registered a deceleration peak of 42G, but thanks to the absorption properties of the barrier Sainz Jr was unhurt.

The only problem was that it was difficult for the F1 medical team to know this as the first row of the barrier came to rest on top of the front of the car and driver during the impact.

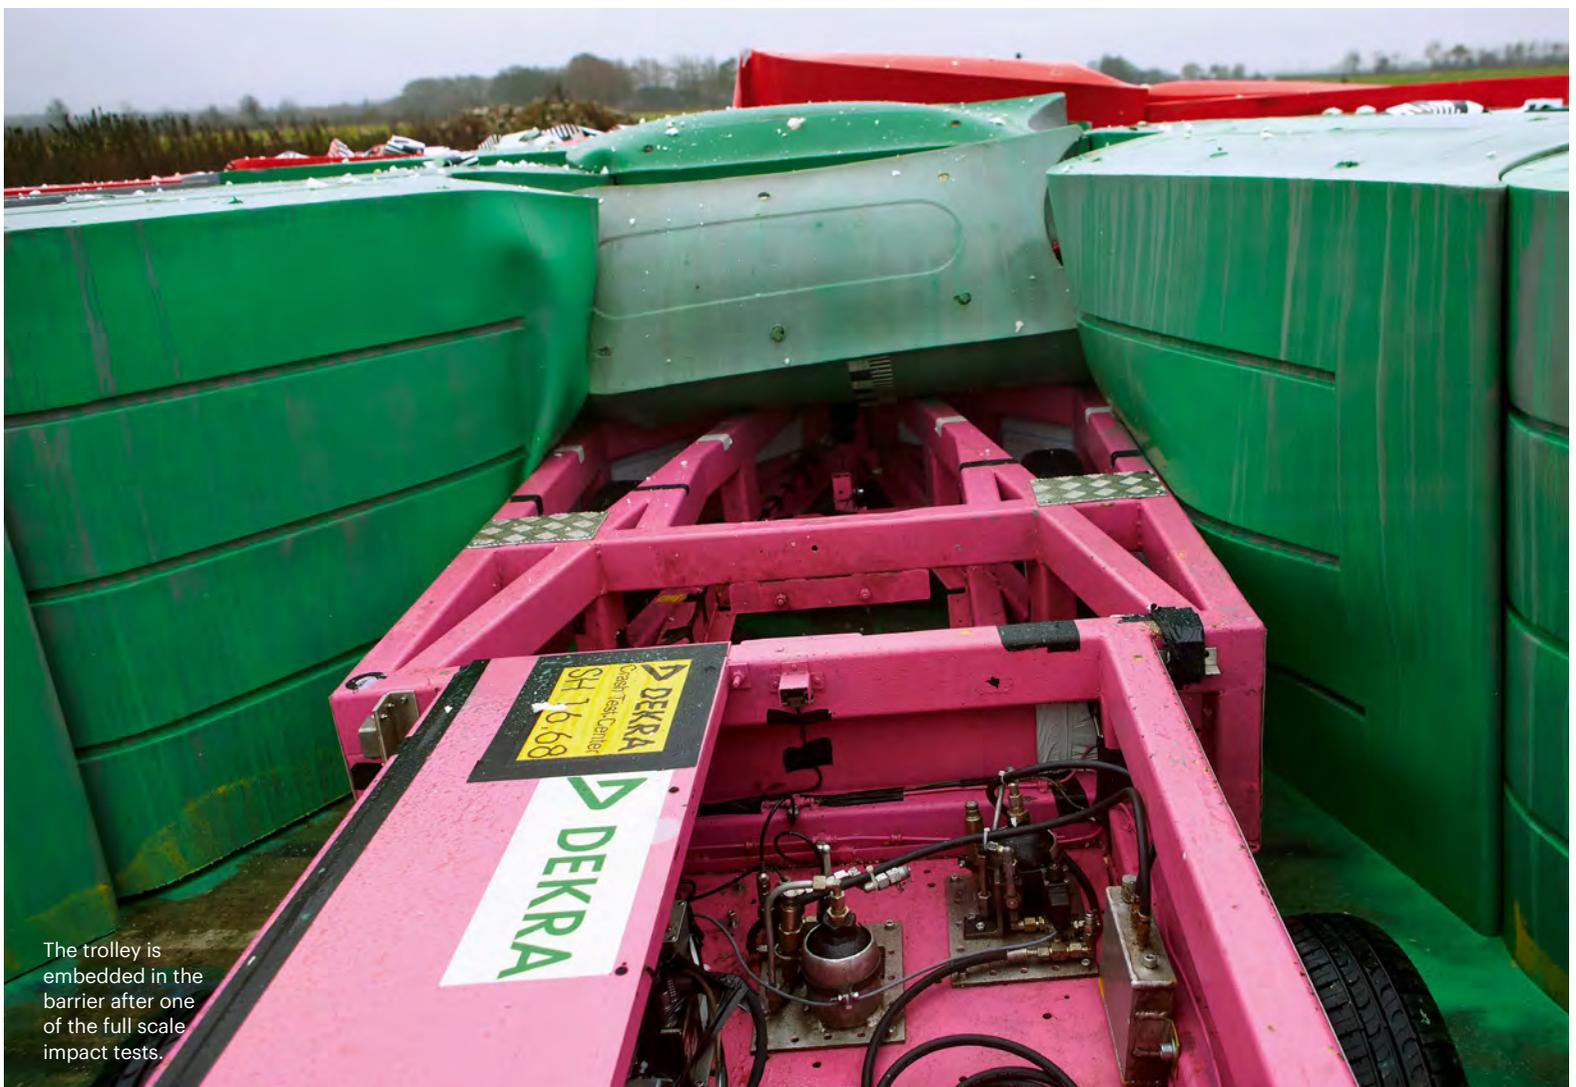
The trolley is embedded in the barrier after one of the full scale impact tests.

“The first step was trying to reproduce what happened [in Sochi] because if you don’t reproduce it with your testing facilities then you are unlikely to be able to mitigate it,” adds Mekies. “So we set up testing with a full-scale barrier and a trolley at the same weight as an F1 car with a real F1 nose.”

This was achieved using a pulley system, which fired the trolley at the barrier. The trolley was fully equipped with sensors, which were synchronized with high-speed cameras placed around the test area to ensure the correlation between data analysis and video.

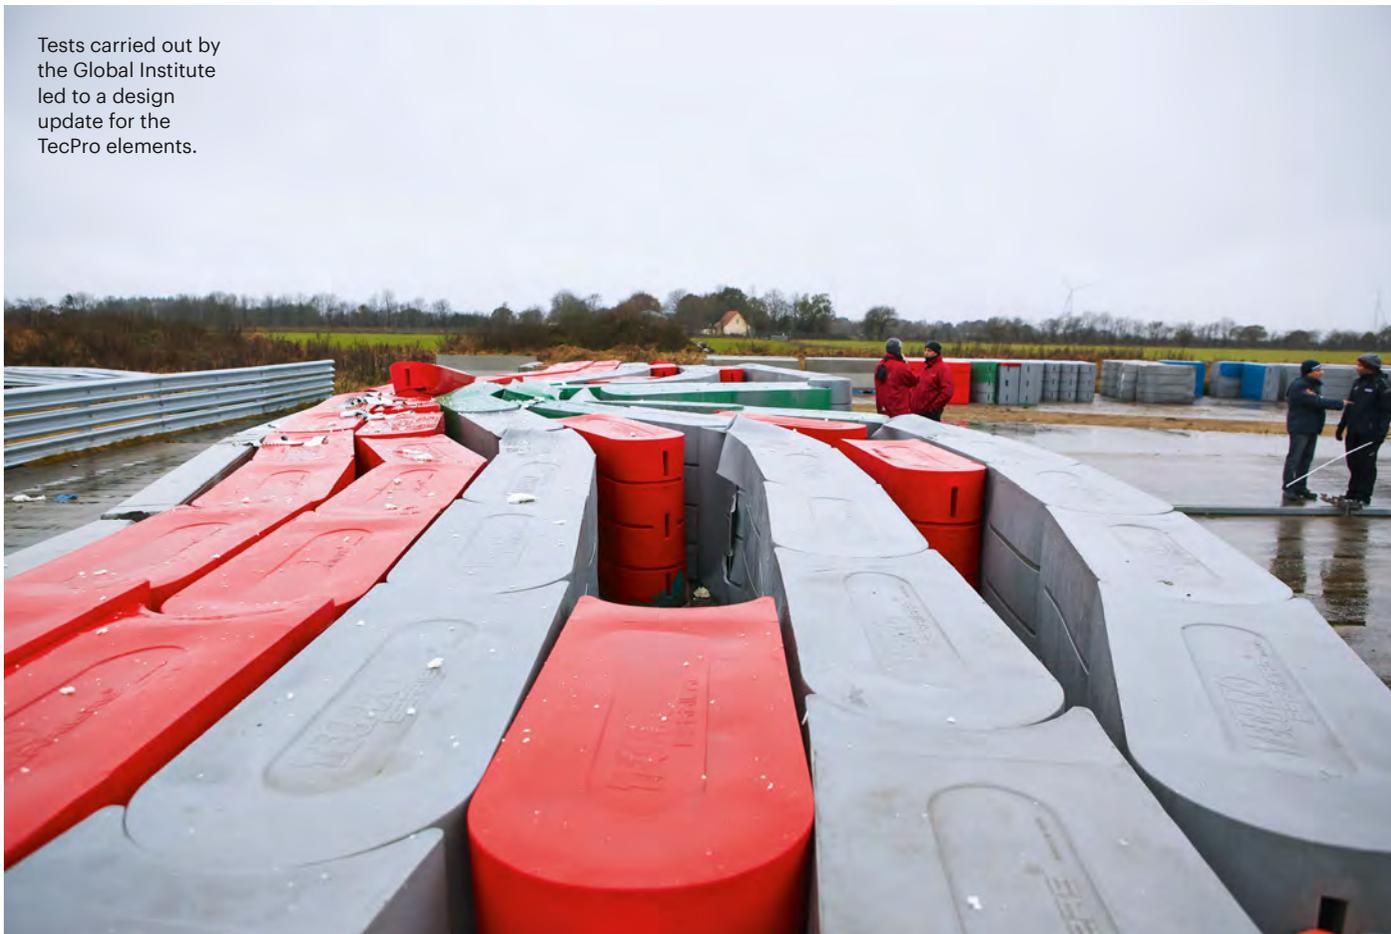
Tests carried out by the Global Institute led to a design update for the TecPro elements.

Having successfully recreated the accident with a comparable level of deceleration peak, Piraccini soon discovered that to mitigate the lift-up tendency of the barrier during the rebound phase the main area to develop was not only the barrier configuration, but also the TecPro elements themselves. The solution was to give each element a lower centre of gravity, increased weight and a stronger internal structure, all of which would help to prevent the element from leaving the ground.

To achieve this, Piraccini worked with TecPro to develop the internal structure of the element. The new solution is heavier than before meaning that the element’s centre of gravity is now lower. At the same time, the new layout increases the strength of ▶

the full internal structure, while improving the element's anti-penetration capability.

"Thinking about the Formula One nose like a knife, with the new element it is less easy for it to penetrate the internal structure because the new solution gives it more strength," explains Piraccini. "We are not talking about a brand-new barrier, we are talking about a natural step forward of the barrier that was designed and tested in the past, and which was already approved. This is the solution to mitigate a particular problem, increasing also the absorption properties of the barrier during an impact."
